Slope Protection – Soil Bioengineering with Coir

C.R. Devaraj
 Managing Director
 Charankattu Coir Mfg Co P Ltd,
 Shertallay, Kerala, India.

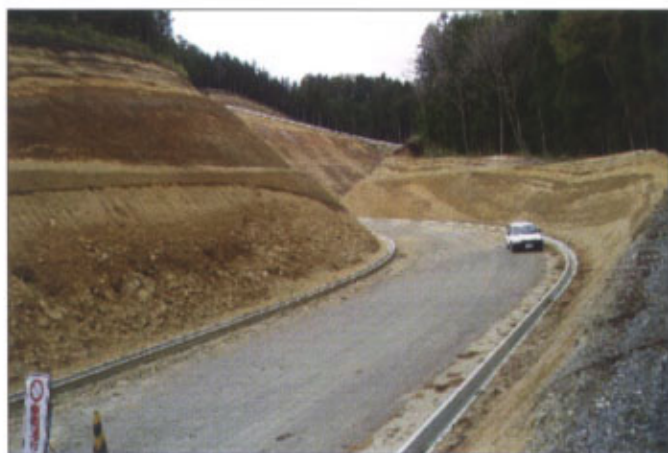
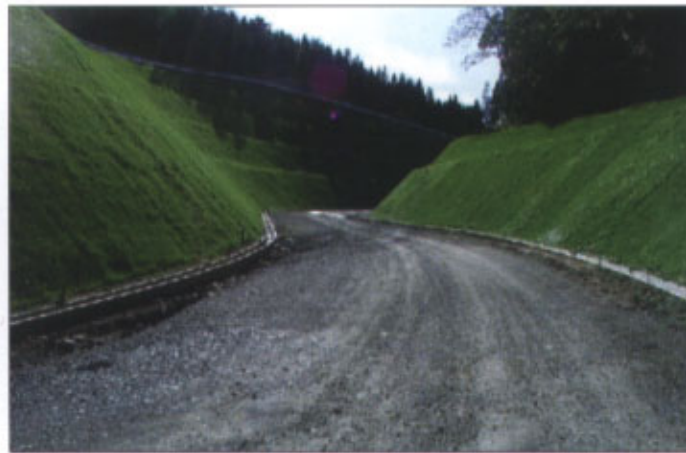
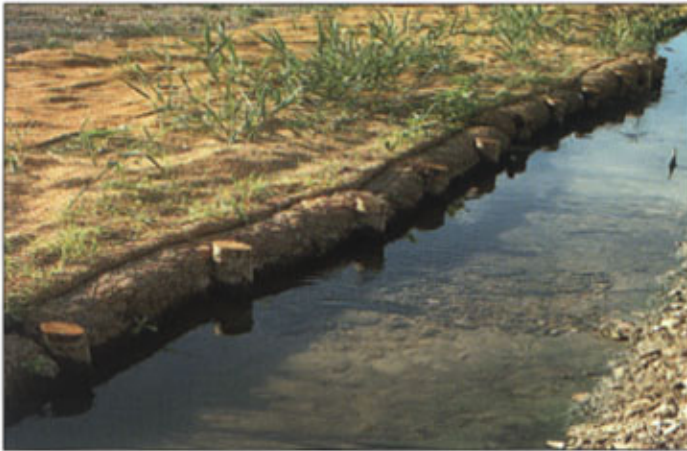
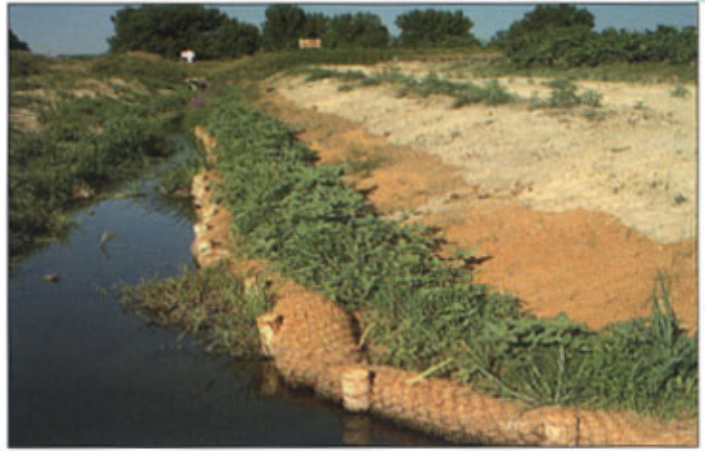
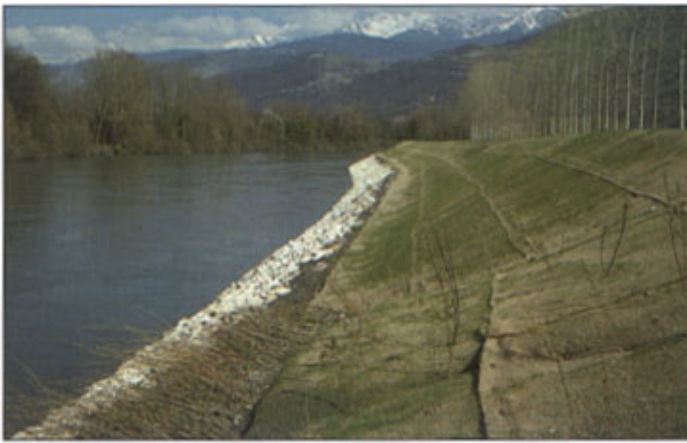
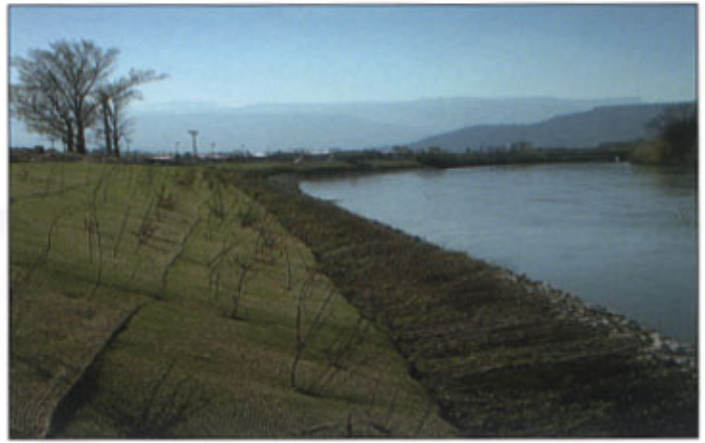
A downstream rebound of the floodwaters off the coir fiber log revetment did occur. This was due primarily to the lack of

vegetation in the coir fiber logs at the time of flood.

The coir erosion control blankets are designed for flow rates of 3.66m/sec (12ft/sec) without vegetation. The vegetation development that had taken place before the flood increased the erosion control blankets ability to withstand greater flow rates.

The coir fiber revetment walls provided medium stream bank protection. As the coir fiber logs biodegraded, the plant root system armored the bank, and as the plants developed they slowed the down stream erosion caused by water rebound off the coir fiber log revetment. Additionally, the coir fiber log revetment was easily installed without machinery. This reduced the impact on the zone being protected. However, log crib revetments and rock and root wad revetments required heavy equipment for installation. This operation equipment can often

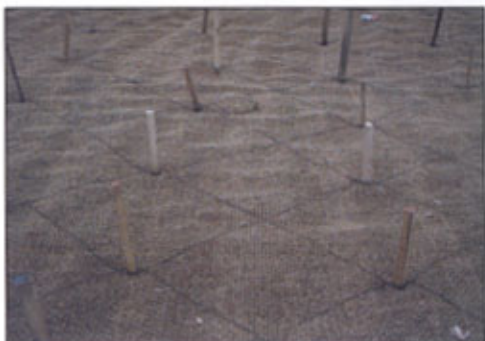
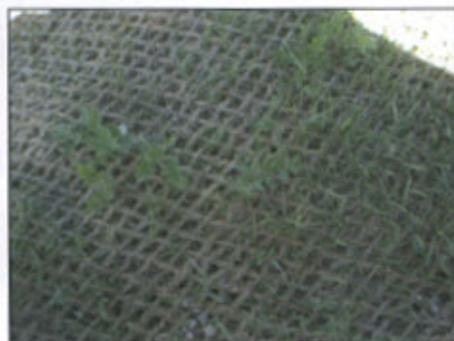
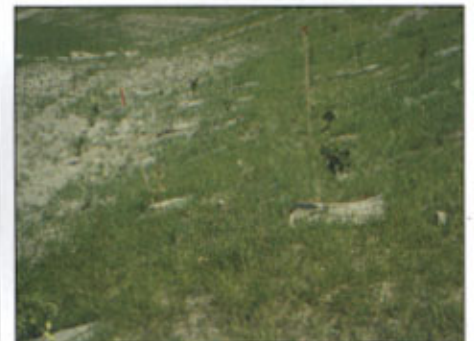
Coir fiber logs were chosen because they were constructed of soft, natural fibers. They were installed to absorb the energy of high water flows along the creek channel. This soft armor, technique dampened the rebound effect of the water flow, thus reducing the water energy's impact on the down stream bank and reducing down stream erosion.

The first coir fiber lift was installed on rock rubble at the toe of the stream bank. The rock rubble was placed in a trench below the creek bottom. The second and third coir fiber log lifts were stepped back 15cm (6 in). The coir fiber logs were anchored with wood stakes 120cm (4 in) on center along the stream face of the logs and on the soil side of the logs. The upstream end of the coir fiber log installation was keyed into the bank.

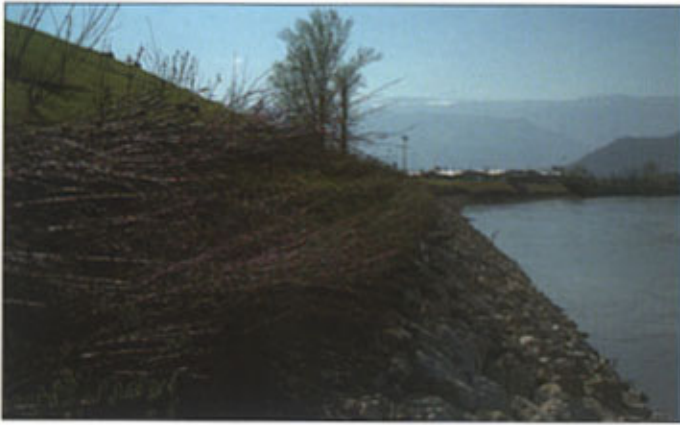
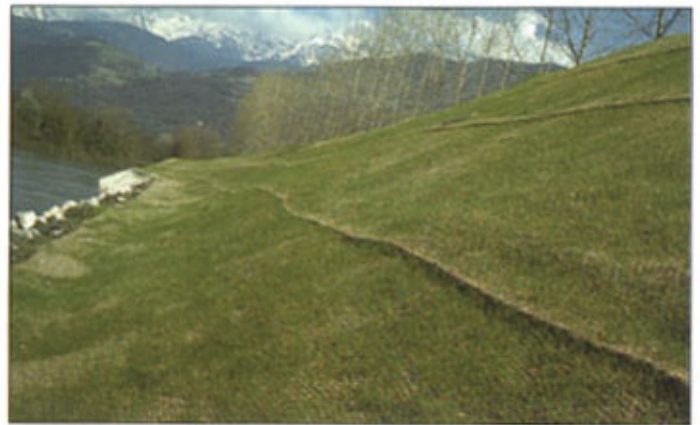
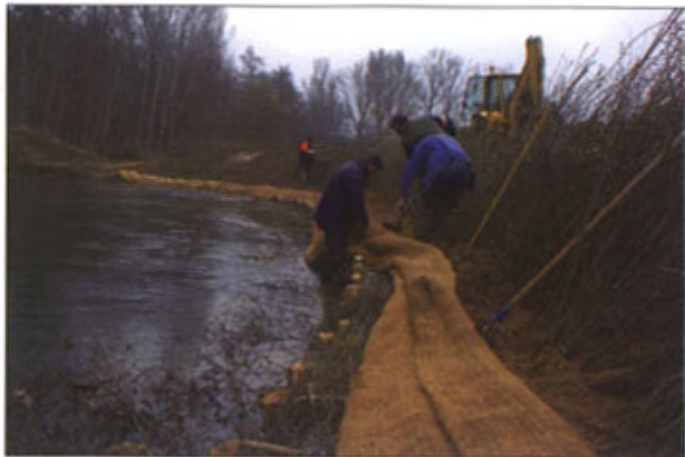
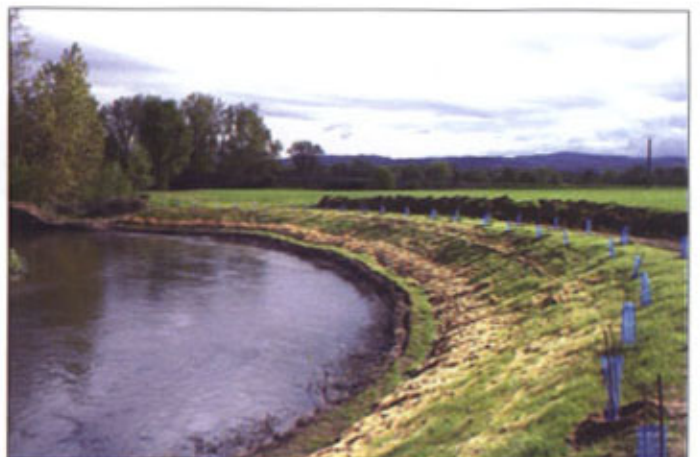
Brush layering was installed between the soil wraps and at other points along the slope. That new practice was geotextile flaps, which involves allowing the coir netting to lie as a flap over the face of the slope instead of wrapping the netting back over the soil, as performed with soil wraps. The flaps were with wood lathes along their edges and long wood/ steel anchors driven into the slopes.

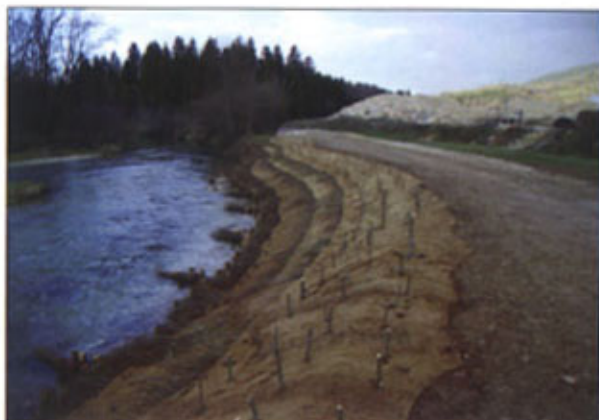
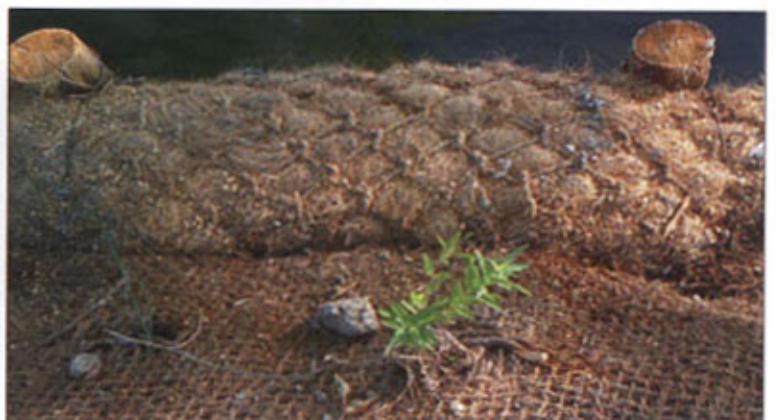
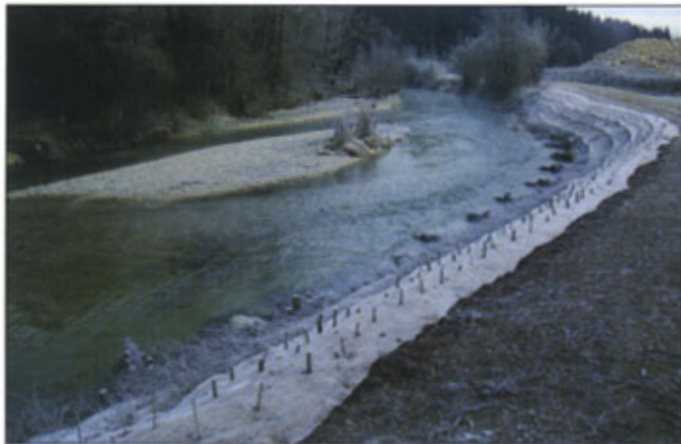
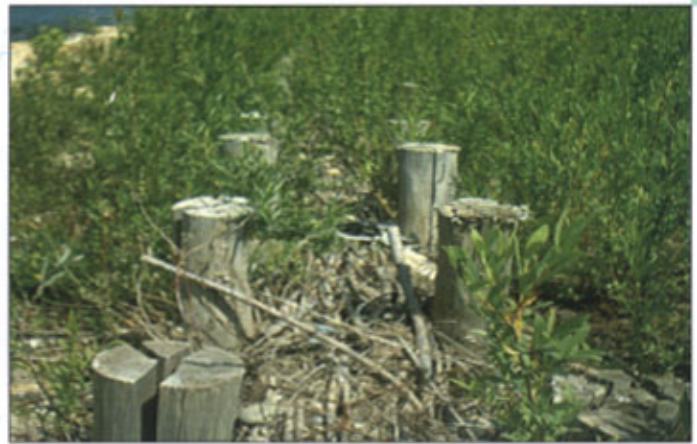
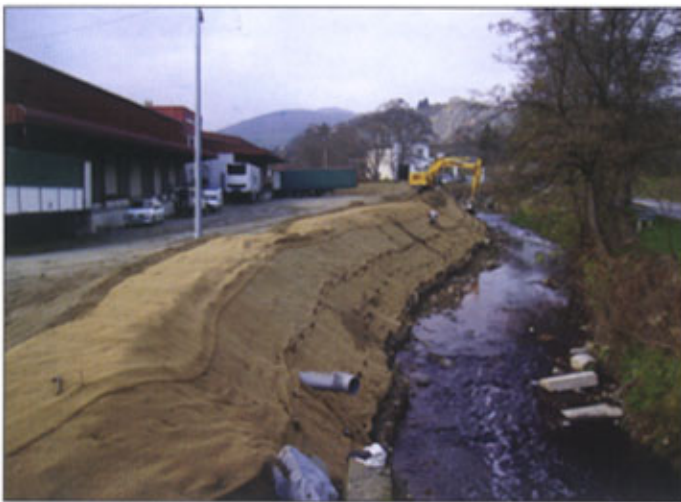
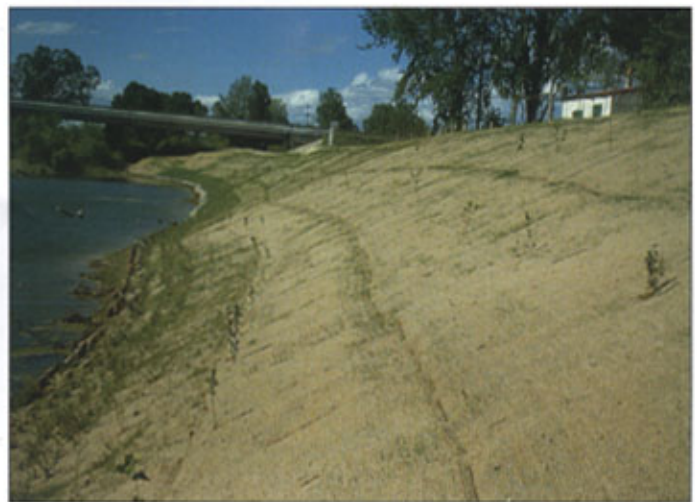
The coir logs used on the project are composed of shredded coconut husk fiber packed at 144 Kilograms per cubic meter (9 pound per cubic foot) into polyethylene mesh netting exterior. They are 30.5 centimeter (12 inch) diameter cylinders, 6.1 meters (20 feet) in length and weighing 65.3 kilograms (144 pound) each when dry.

Proper installation is critical to ensure any successful erosion control project with careful grading of the vertical portions of the top of bank using a backhoe to create a more gradual slope (1.1 to 1.5: 1) for improved stability and larger planting area. A row of hay bales was staked along the lower bank prior to grading as a sediment trap, which prevented any soil from falling in the river. The coconut fiber rolls were installed securely with wooden stakes cut diagonally from 1.2 meter (4 foot) to 1.8 meter (6 foot) long construction lumber measuring about 5 centimeters thick by 10 centimeter wide ("two by- fours"). The rolls were anchored by a network of polypropylene cords attached to notches in the stake and then hammered down taut with the surface.

The coir fiber logs withstood the floodwaters of very well. They were not damaged by ice, and the soil behind the coir fiber logs did not erode. Some sediment was deposited on the log surface. The planted dogwood as well as volunteer vegetation had taken root and began to develop.

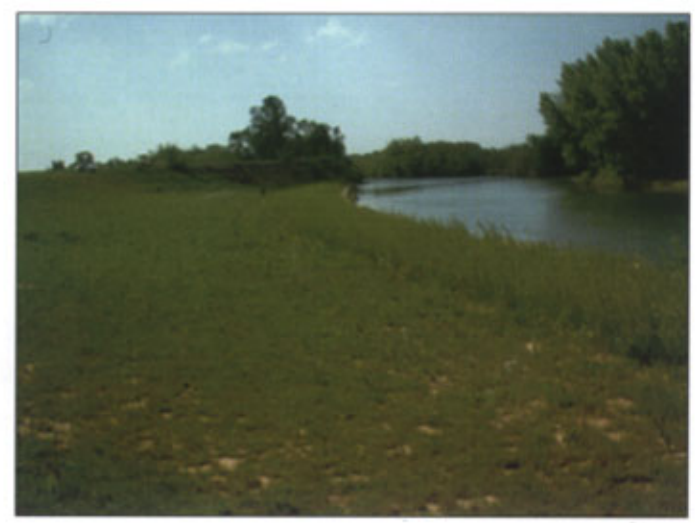
higher flow velocities. The treated stream bank has now successfully held up to several storm events over four winter. An eroding bank unable to support vegetation and with little wildlife use has now been stabilized and restored to a valuable and scenic native riparian habitat, threats to adjacent land have been eliminated, and erosion/siltation minimized. This project demonstrates that biotechnical stream bank stabilization is a viable alternative to riprap that can reduce erosion and sedimentation while enhancing habitat values.
